DIAX04

Drive With Servo Function

Trouble Shooting Guide: SSE 01VRS

DOK-DIAX04-SSE-01VRS**-WAR1-EN-P

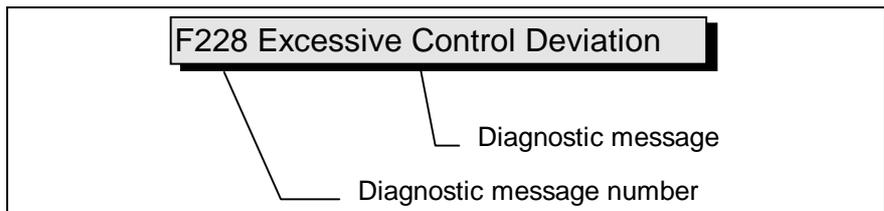
Fig. 1-1: Diagnostic message with a diagnostic number and text.

For the example in the graphic, "F2" and "28" are shown alternately on the H1-Display.

The clear coded diagnostic message contains the diagnostic number followed by the diagnostic text, as shown in the example, "Excessive Output Error" (Fig. 1-1). It can be read out with the **S-0-0095, Diagnostic Message** parameter and directly displays the operation status on an operator surface.

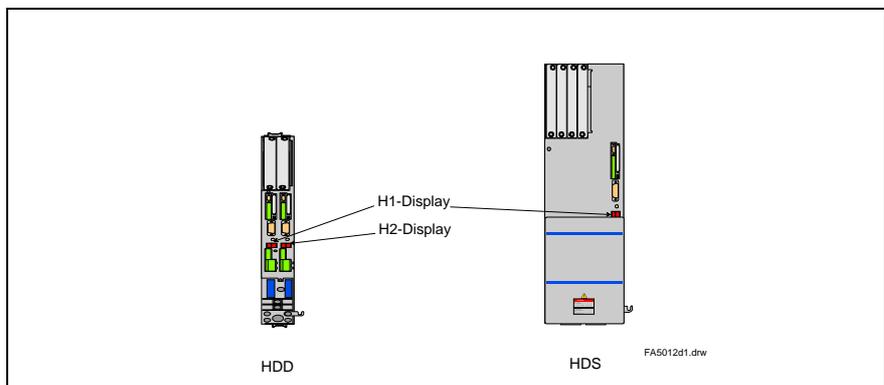
The H1 display is the visual representation the diagnosis of the drive controller. H2 serves two-axis units (HDD) as an addition display.

Fig. 1-2: H1 and H2 displays on the HDS and HDD controllers

The diagnostic number appears on this two-positional seven-segment display. The image can be seen on the "Diagnostic Message Priority Display".

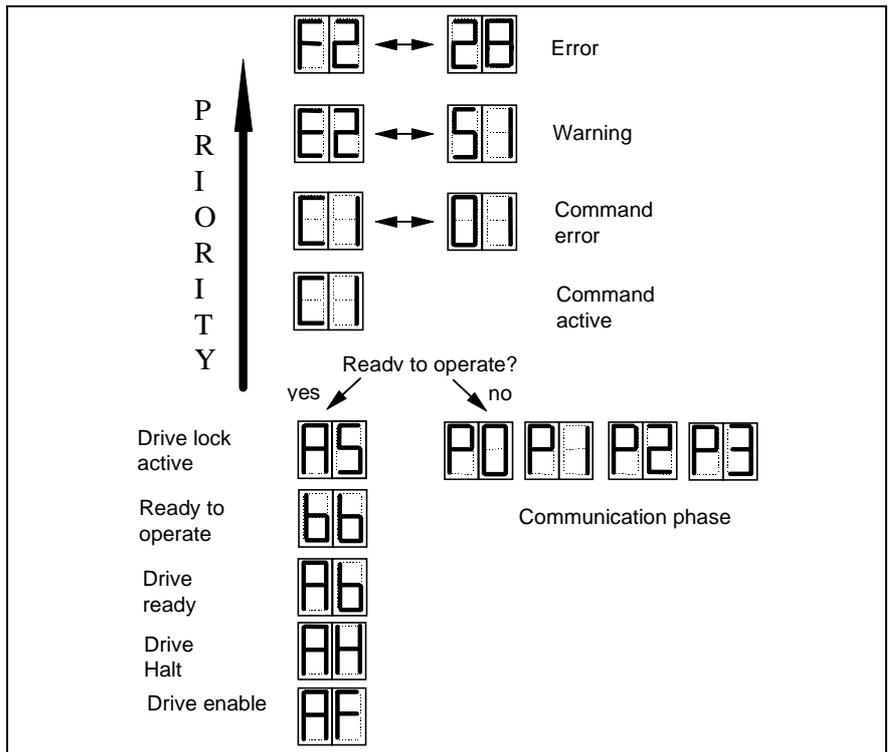
If more than one diagnostic message is waiting, then the message with the highest priority will be displayed.

The following graphic classifies operation status in order of importance.

Fig. 1-3: Diagnostic message priority diagram

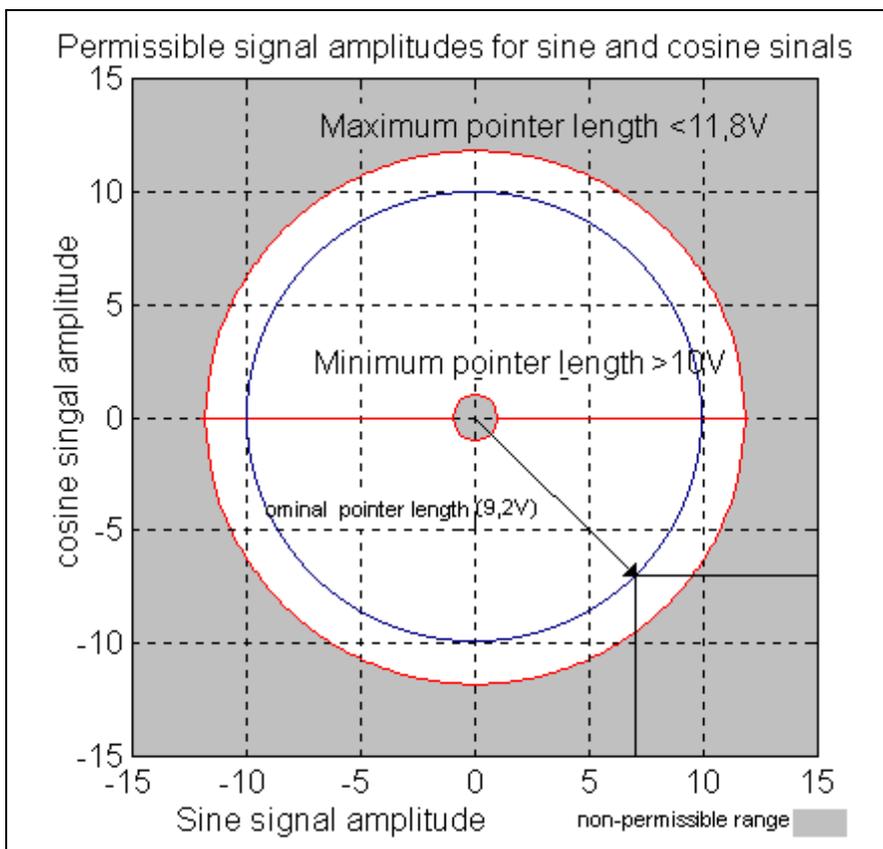
$$\text{pointer length} = \sqrt{\sin^2 + \cos^2}$$

Fig. 2-1 Pointer length

Fig. 2-2: Correct signal amplitude

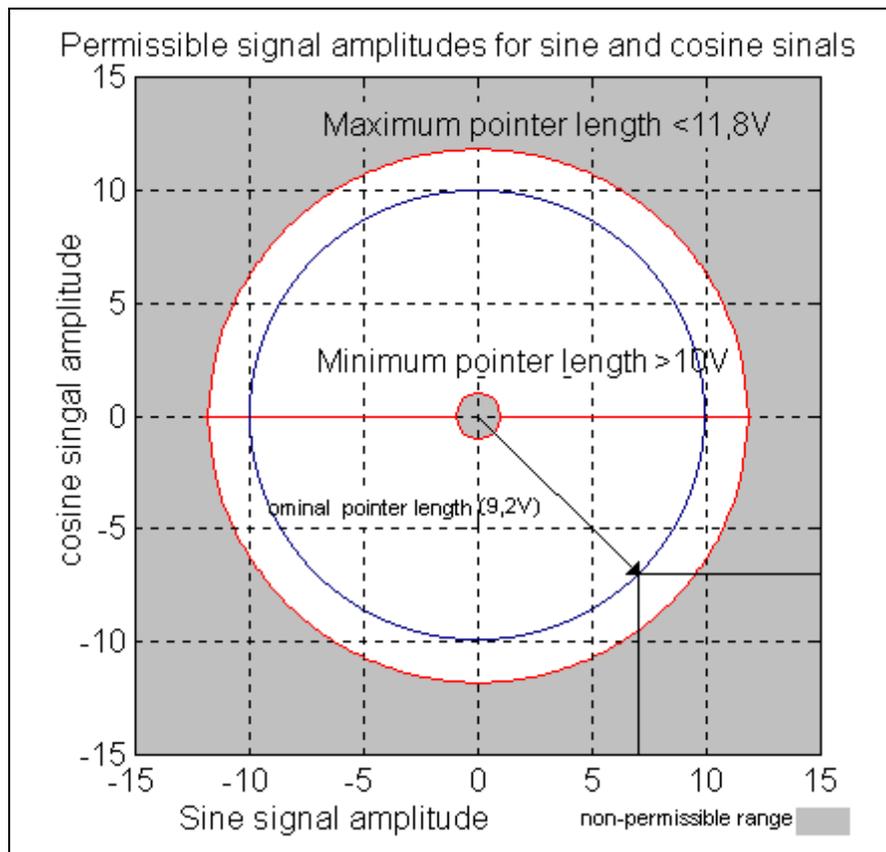
$$\text{pointer length} = \sqrt{\sin^2 + \cos^2}$$

Fig. 2-3: Pointer length

Fig. 2-4: Correct signal amplitude
